FORM B - BUILDING

Address 46 Harding Road

Historic Name John and Hilda Andresen House

BUILDING FORM (46 Harding Rd.)

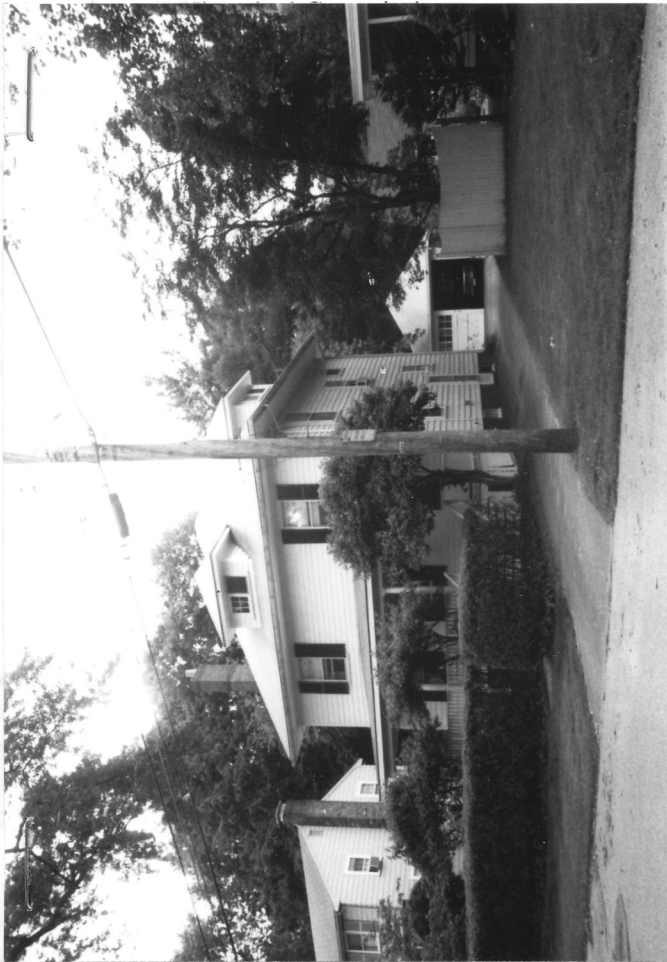
The house at 46 Harding Road (MHC #1061) is a good and well-preserved example of the Four Square style, a style which appears to have found limited popularity in Lexington in the early 20th century. Characteristic of the style, the clapboarded dwelling is capped by an asphalt-shingled hip roof with overhanging eaves; hip-roofed dormers are centered on each of the elevations. The house rests on a brick foundation with a brick exterior chimney on the south side breaking through the overhanging eaves. The wide facade is fronted by a single-story porch supported by Roman Doric columns with single stick balusters. Sheltered by the porch is a sidehall entrance and two 6/1 windows; the upper story of the facade is punctuated by two 6/1 windows.
